# SBC<sup>TM</sup> magazine

March 2018

## A Memorable Revival

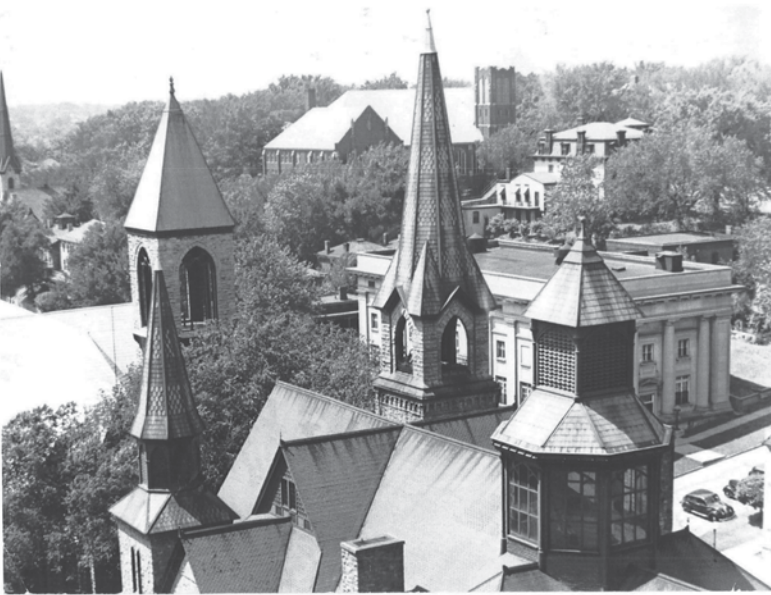
*Historic tax credits prompted the architect to do significant research into the original look of the building.*
